UGANDA

THE PROJECT

Project Location: Kidere, Gulu, Uganda

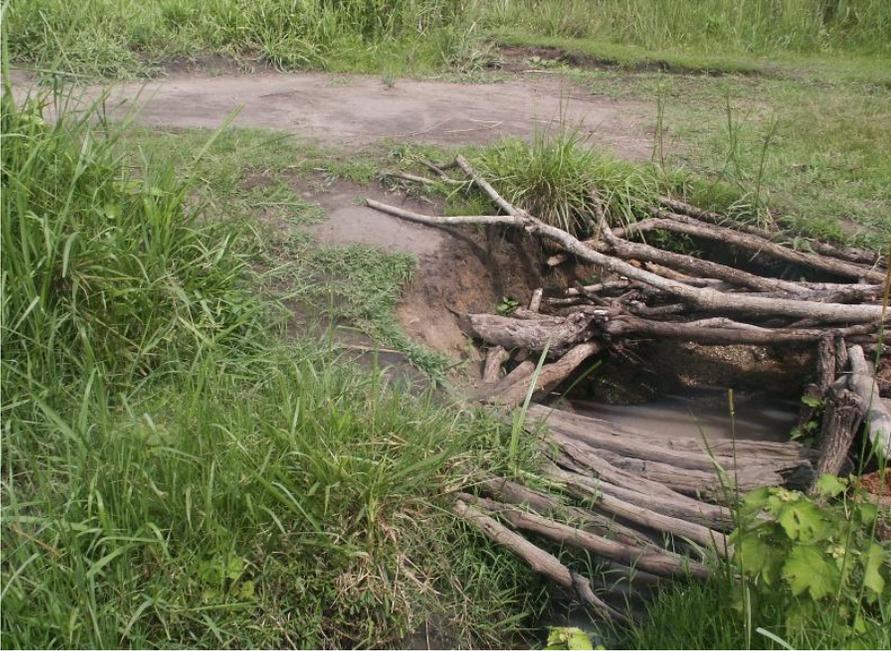
The previous water source, an unprotected water source located two kilometers away from the community to meet all of their most immediate water needs.

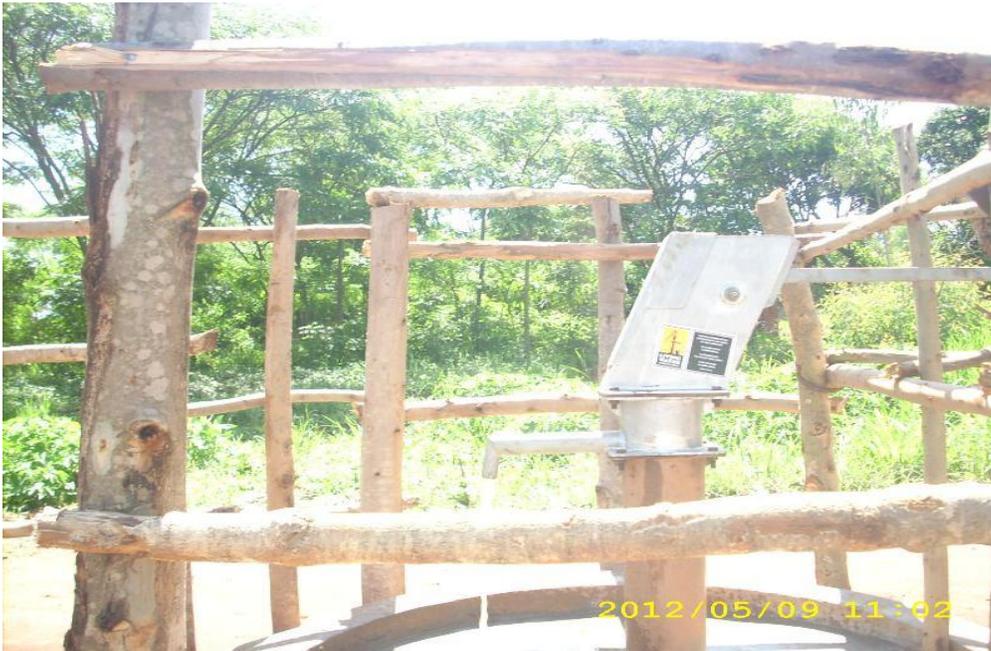
A completed water project that pumps out and provides safe, clean water.

Location Name	Kidere	
Type of Location	Village	
Region/Province/District	Gulu, Uganda	
GPS Coordinates	Latitude:02 47.203 N	Longitude: 032 22.325 E
Altitude	1210 m	
Total depth	45 m	
Static level	13 m	
Diameter of casing	150 mm	
Casing material	PVC	
Screen	Start: 25m	Stop: 31 m
Pump Type	India Mark II	
Depth of cylinder	24 m	
Well yield	20 liters per minute	
Gravel pack	Yes	
Sanitary seal depth from surface	2	
No. of people served	500

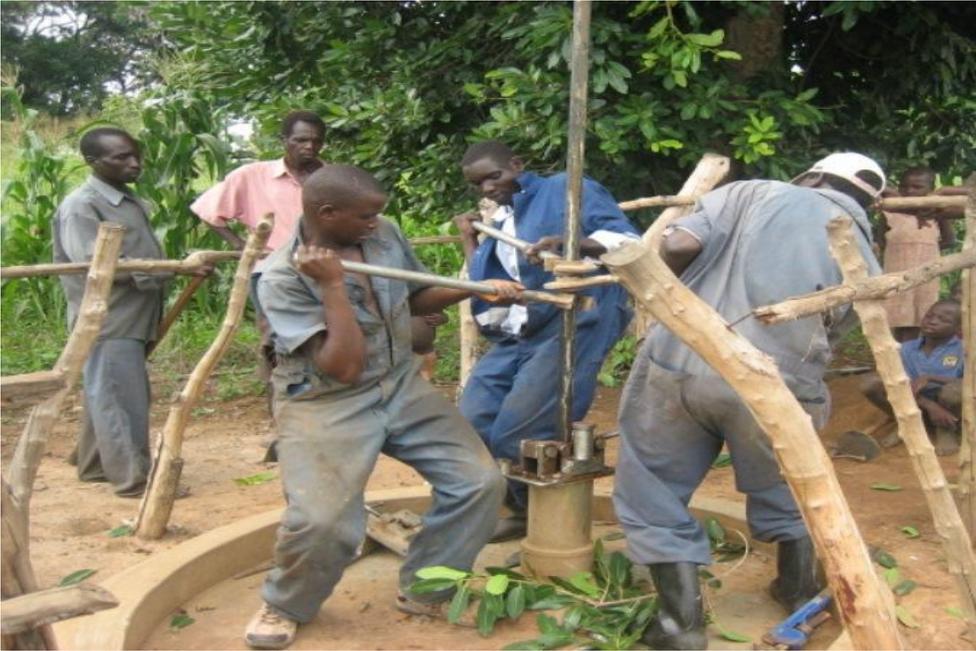
The project in process and the community members assisted the team whenever possible.
